Goshen Theater

Feasibility Study

ARCHITECTURAL

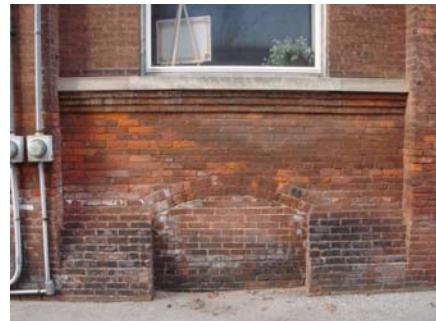
South façade base detail

The masonry along the lower walls of the south façade is in the poorest condition. The stepped detail at the base of the masonry allows water to stand and work its way in to the joints.

Additionally the use of salt on the alley is deteriorating the face brick. It is recommended that this practice be stopped to control the deterioration of the brick. The brick under each window sill also shows signs of mortar washout along with the joints at the window header.

The vertical and skyward facing stone joints should be pointed and sealed. The project should allow for 50 percent of the brick to be pointed, with a mortar to match the color and density of the exiting mortar. The alley is crowned in the middle shedding water directly towards the building.

To control the water infiltration into the basement of the building, the alley pavement must be reworked. It is recommended to reform the alley to allow the water to run in the center and out to the main roads for collection or add drains in the center. Some of the windows and doors have been replaced over the years. Some windows have been in-filled with either masonry or wood to allow for the building to utilize the space within the building. It is recommended to replace the wood in-fill for five of the openings to ensure a weather tight system. Two windows that were not replaced should be repaired and new insulating or laminated glass should be installed. All of the doors along the alley should be replaced to ensure proper function and door seal.

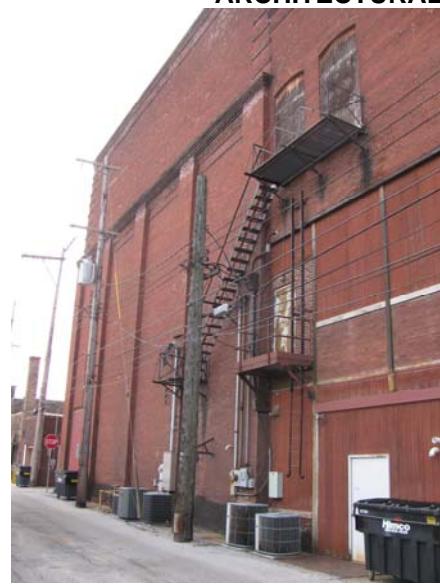
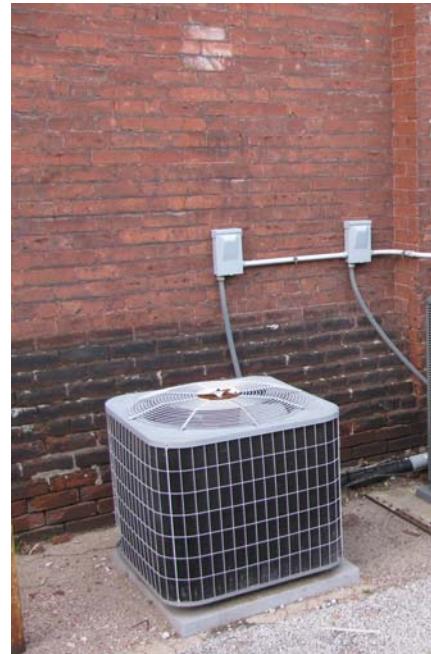
The East façade or rear of the building continues the details of the South façade but has few windows most of which have been covered over.

The same issues occur at the lower three feet of the building, where the stepped masonry coursing is in need of repair. This elevation is the most damaged by water. It is estimated that 50% of the lower three feet of the wall should be rebuilt with the remaining pointed. Also to control water into the basement all of the access panels into abandon coal rooms and fuel oil should be removed and filled in. The upper portions of the façade related to the Menno Travel space have windows and doors that are either filled or boarded over to control air infiltration and damage. There are also two levels of fire escapes from the third and second floors from the Menno Travel side of the building. When the upper areas of the Menno Travel side of the building are reopened, these fire escapes will require replacement. The doors and windows should be repaired or replaced. Neither of these items is recommended at this time.

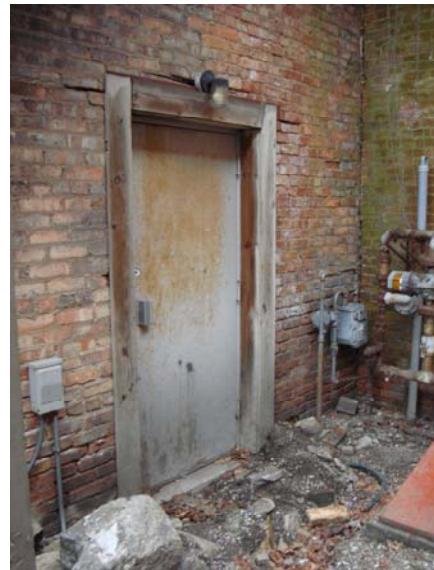
North façade (East entry)

Although this façade is the common wall between two buildings, the condition of the brick along the lower portion of the wall is poor. The major concern is the water infiltration that has occurred over time. The mortar is washing out of the joints creating a pathway for water. It is recommended to point approximately the lower 24 inches of the building and around the east entry door. The upper windows are covered over for protection. These should remain in place until renovation of the upper floor is considered.

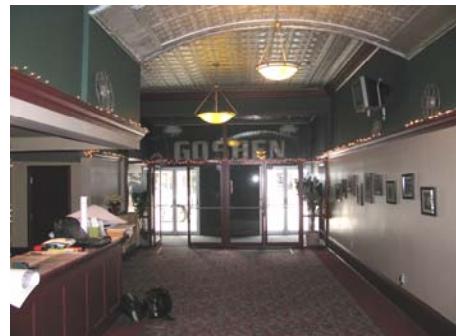
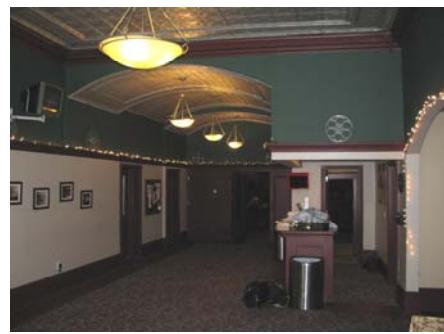
Main Lobby

The lobby is small relative to the 750 seat capacity of the auditorium. The concessions counter also reduces the area for patrons to wait during a preshow or intermission. The main toilets for the theater are located in the adjacent commercial space. The men's toilet room is accessed from the lobby and the women's is accessed through the auditorium space. The total water closet fixture count of three (one for male and two for female) is below the required amount to meet today's code standards. By today's standards the total water closet fixture count at minimum should be nine (three for men and 6 for women for a facility of this seating capacity. However, theaters have a need for a higher water closet fixture count do to the short show intermissions and quantity of people needing to utilize the facility. Additionally some attempts have been made to provide accessibility to these water closets but this access needs more improvement.

The theater lacks the necessary patron amenities to support the types of programming that they desire to offer. The biggest deficiency is the toilets for patrons. The recommendation is to develop these services into the rear portion of the North commercial storefront. The expansion would include new toilets for both men and women that are ADA compliant and at a quantity to support the capacity of the theater. These would be accessed through an opening in the wall between the two spaces. The lack of space within the lobby is also of concern. To remedy this the recommendation is to remove the concessions counter that is within the main lobby and relocate this to the rear of the

North storefront commercial space and provide an opening with a counter from the storefront to the lobby. With the commercial space and South storefront already connected, we are recommending the storefront to be redeveloped to act as an extension of the current lobby for patron overflow and other pre and post show events.

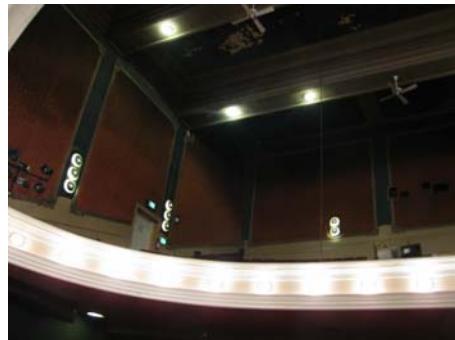
Balcony

The balcony has not been utilized for seating because of the current condition of the wood flooring and the seats. The balcony is accessed via two stairs located in the rear and to either side of the audience chamber. The balcony seating can accommodate approximately 300 patrons. Some of the seating has been removed to allow for a technical lighting and sound control position.

The audience chamber is generally in good condition. The seating capacity if all seats were usable would meet the needs of the program. However, the location for wheelchairs is not ideal. We are recommending the orchestra seats to be refurbished and at the rear of the seating area spaces should be left to allow for wheelchair locations. Additionally, the floor at the center section of the seating should be reinforced from below to reduce the spring in the floor. With the program variety the floor under the seats and the aisles could be painted or carpeted. At this time we are recommending the aisles be carpeted and the area under the seats be painted. This would also occur at the balcony; however the seat would be new based on the condition of many of the seats at that level.

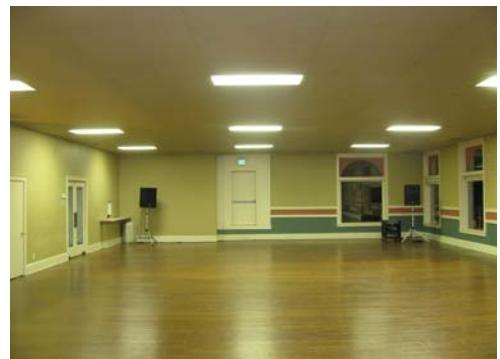
Third floor multi-purpose room

The primary character of the space is the size. In the original drawings the space was noted to be a lodge hall with an adjacent ante room. We believe the multipurpose room is within the original lodge hall space. It was not confirmed but the original metal ceiling may still survive above the contemporary acoustic tile ceiling.

This would provide the appropriate ADA accessibility to this level. The space would also get new flooring and repainted walls. As for the ceiling, the recommendation is to remove the acoustic ceiling tile system to reveal the original metal ceiling. The lighting could be pendent fixtures with the HVAC ductwork running above the ceiling.
