Goshen Theater

Feasibility Study

ARCHITECTURAL

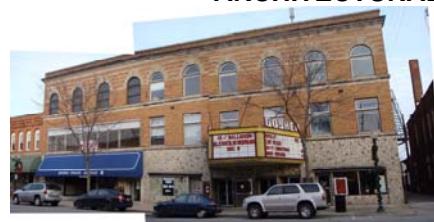
West facade

These were once all operable one over one windows. Above the Menno Travel space, the windows change to a wide continuous glazed area. This was changed during the reconstruction of the building after 1906. The sill of the windows is the separating cornice, and none have a decorative lintel. The third floor of the façade is again separated by a cornice which also acts as the sill for the windows. At this level the windows are more detailed with half round tops of stone in a keystone pattern. Also at this level stone is introduced in a striped pattern starting at the spring of the arched windows. The top of the building is capped with a decorative dentil styled stone cornice and corbelled parapet and stone coping.

The second and third levels of the building brick and stone façade are in good condition. It is recommended that the upper level brick and stone be cleaned by a non chemical process. Once cleaned the vertical and skyward facing stone joints should be pointed and sealed. The project should allow for 20% of the brick to be pointed, with a mortar to match the color and density of the exiting mortar. On the West elevation there are sixteen window openings (punched) and one continuous glazed unit above the storefront level. Twelve of the windows have been replaced with a single picture style while the reaming four appear to be original to the building. The twelve windows that were replaced would remain and only receive simple repair and paint. The four original windows above the Menno Travel storefront at the third floor would require removal to repair the sashes and frames, and install insulated glass within the existing profile of the window.

The veneered “field” stone from the south corner to the Menno Travel section of the building should be removed. It is expected that the removal of the veneer will severely damage any underlying stone from the original building. Care should be taken to save any and all possible underlying stone; however, it should be assumed all of the stone will be replaced with matching color and size to replicate the original design.

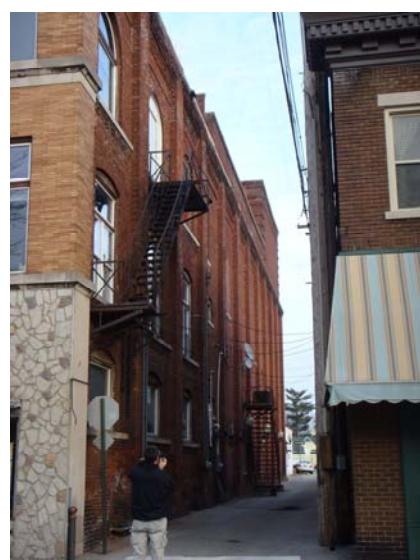
South facade

The masonry along the lower walls of the south façade is in the poorest condition. The stepped detail at the base of the masonry allows water to stand and work its way in to the joints.

Additionally the use of salt on the alley is deteriorating the face brick. It is recommended that this practice be stopped to control the deterioration of the brick. The brick under each window sill also shows signs of mortar washout along with the joints at the window header.

To control the water infiltration into the basement of the building, the alley pavement must be reworked. It is recommended to reform the alley to allow the water to run in the center and out to the main roads for collection or add drains in the center. Some of the windows and doors have been replaced over the years. Some windows have been in-filled with either masonry or wood to allow for the building to utilize the space within the building. It is recommended to replace the wood in-fill for five of the openings to ensure a weather tight system. Two windows that were not replaced should be repaired and new insulating or laminated glass should be installed. All of the doors along the alley should be replaced to ensure proper function and door seal.

The two fire escapes along the alley should also be completely replaced with stairs to grade.

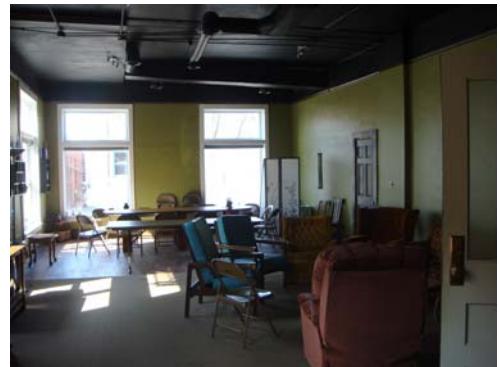
Second floor conference room

The primary character of the space is the size. In the original drawings the space was noted to be a lodge hall with an adjacent ante room. We believe the multipurpose room is within the original lodge hall space. It was not confirmed but the original metal ceiling may still survive above the contemporary acoustic tile ceiling.

At this level the intent is to keep the space functioning as an assembly area for various programs. This would keep the warming catering area and the storage space. The major adjustment is the location of the elevator and a separation of the stair an elevator from the main room.
